Manhole Inspection Summary

Manhole # S35QQ_036MH

Insp Date: **1/23/07 12:30 PM**

Location Address: **2435 GUILFORD AVE**

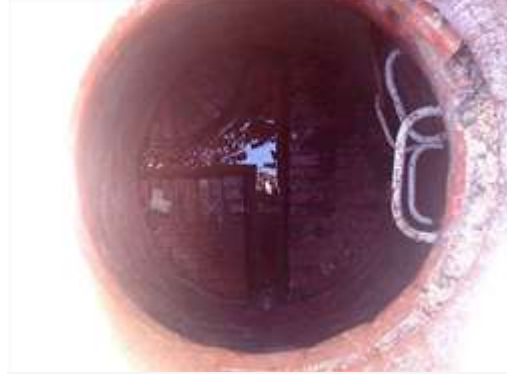
Top View

Bench and Channel debris.

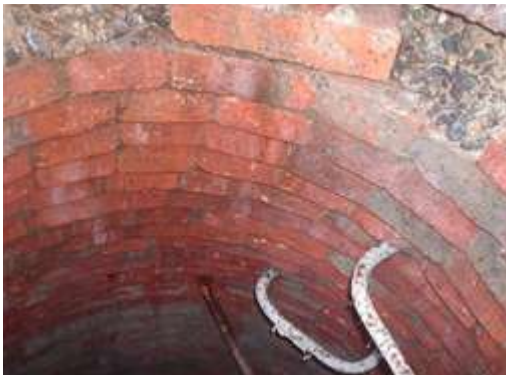
Defect

Frame leaks. Adjustment deterioration and infiltration. Barrel infiltration.

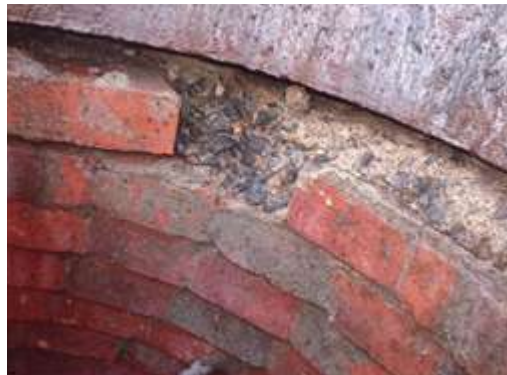
Defect

Frame leaks. Adjustment deterioration and infiltration.

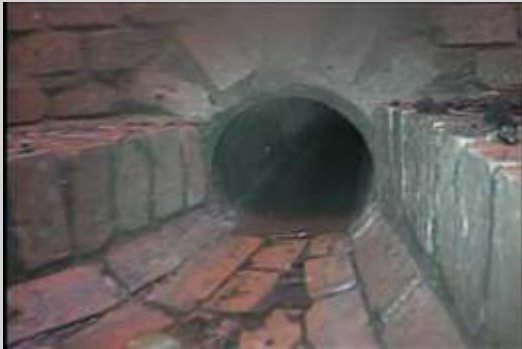
10 in. Circular Gravity Sewer Pipe Out @ 12 O'Clock

Infiltration: **Evidence** Pipe Seal Cond: **Unknown**

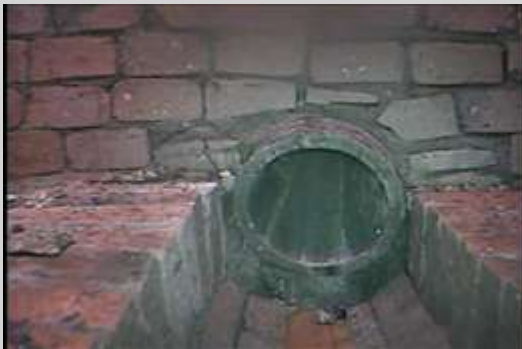
6 in. Circular Gravity Sewer Pipe In @ 6 O'Clock

Infiltration: **Evidence** Pipe Seal Cond: **Cracked**

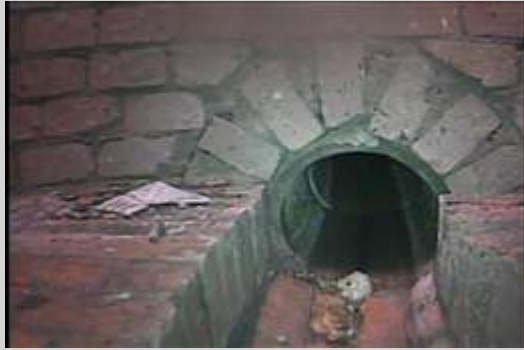
Pipe In @ 9 O'Clock

Deposits: ☐ None ☐ Mud ☐ Sludge ☒ **Debris** ☒ **Grease**

Deposits Extent: **Light**

Infiltration: **Evidence**
